Nor848A Acoustic camera

Filming Breakout Noise from Café and Concert Venue

Measurements in bar and bistro Oslo, Norway, March 2016

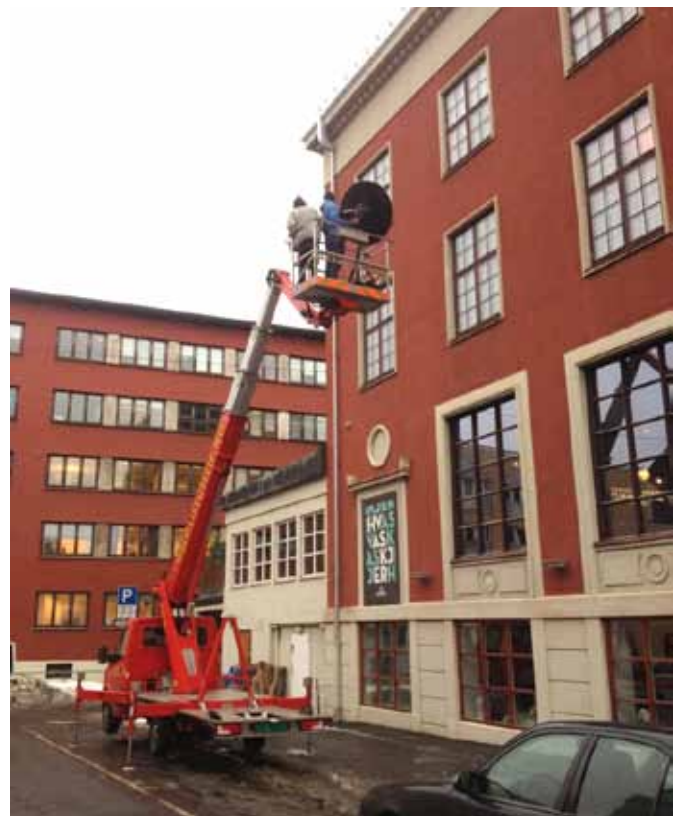
The 1.0 m Nor848A-10 with 256 microphones was used for the recordings. The camera was plugged into an

external battery pack for easy transportation and mobility. In addition to measuring the wall and windows of the concert venue, a wall between the café and a patio area on the ground floor was also of interest.

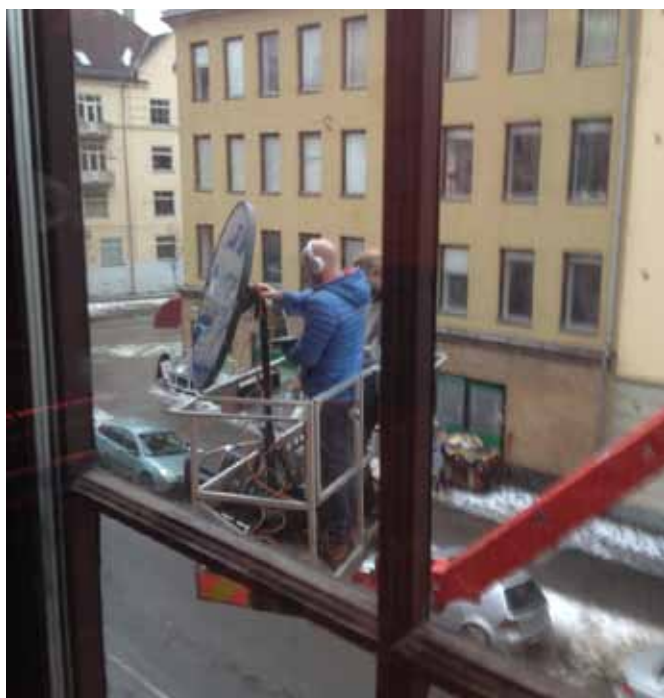
The camera was placed outside pointing at the facade of interest, with the audio system inside of the music venue playing white noise at volumes up to 100 dBA. The room inside would then act as a sending room, and the outside as the receiving room. In order to get close enough to the windows of the concert venue, a truck mounted crane was hired, with both camera and operator around 7 m above ground during measurements.

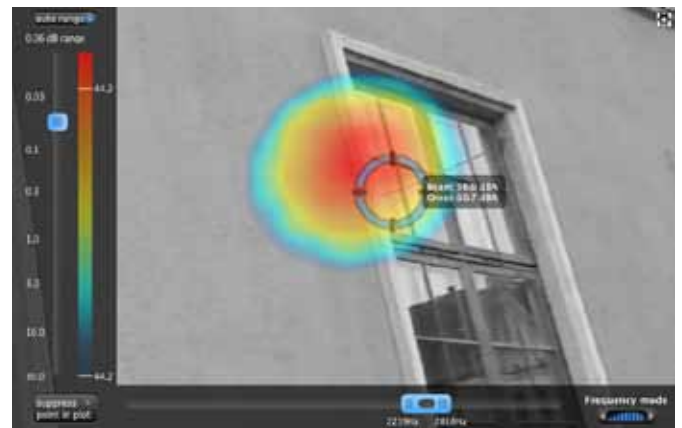
Seen in the pictures below are some of the measurements of the concert venue facade. As can be seen one could quickly rule out that any additional measures had to be taken on the wall itself, as the only sound leakage that could be seen came from the windows only. It was also possible

to zoom in on different areas of interest, either at the site during a measurement, or at a later time in post-processing analysis to further locate weak spots.

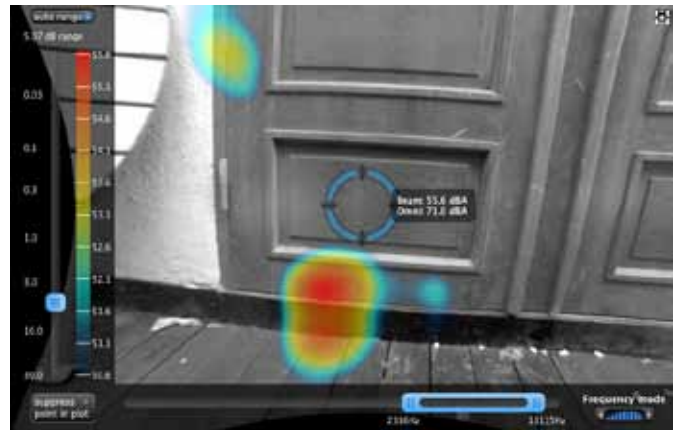
The second measurements were conducted on the patio outside the café on the ground floor. Here the measurement conditions were substantially easier, as the patio was shielded from the city traffic noise. Again the music system of the café emitting white noise was used as source. The wall between the café leading to the patio consists of both a door and several windows. The first step consisted in seeing what made the biggest noise contribution. As seen in the image below, where the dynamic range is set to 10 dB, the door had a noise contribution that was approximately 10 dB higher than the nearest window.
