Nor848A Acoustic camera

Filming Sound Leakages in Highly Reflective Office Environment

Measurements in office complex Lier, Norway, April 2016

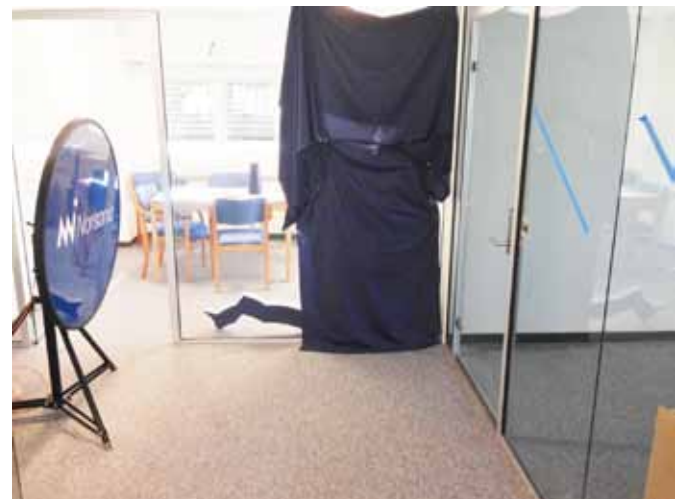
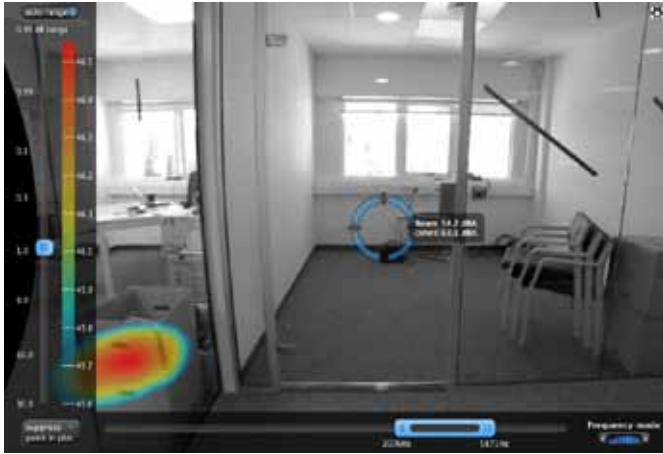
The first results from the initial recordings proved disappointing. Although it was possible to hear clear differences by using the virtual microphone, which enables the user to listen to specific points in the image, the coloring of sources was only seen on a glass facade standing perpendicular to the wall of interest, as seen on

the left side in the image above. Clearly this was a strong acoustic reflection and not the main source itself.

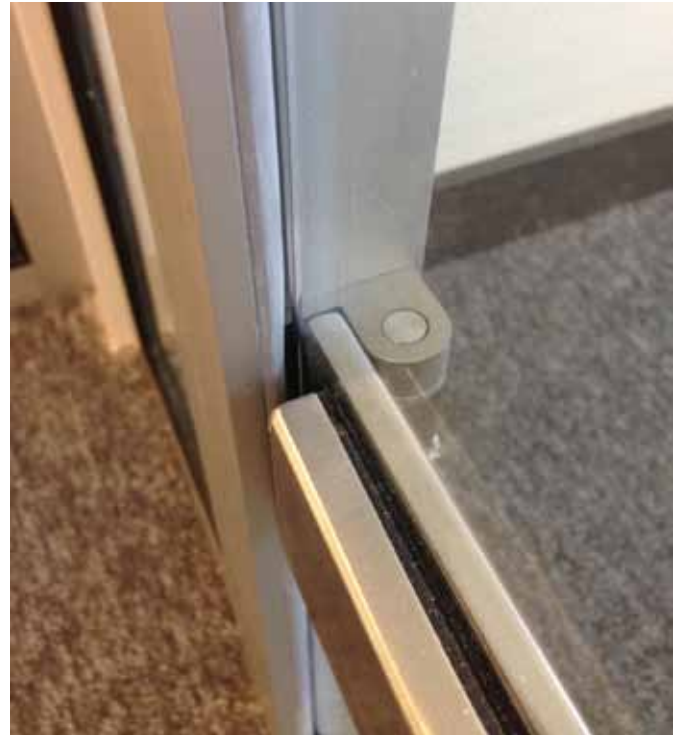
Since the recording environment was highly reflective, a good approach was to try to dampen the influence from surrounding structures. By using a piece of cloth to cover parts of the reflective wall, the acoustic reflection was absorbed enough so that the sources of interest could be visualised as seen in the image below. Now various weak points in connection with the door frame became apparent. Sources were seen between the door and the floor, and

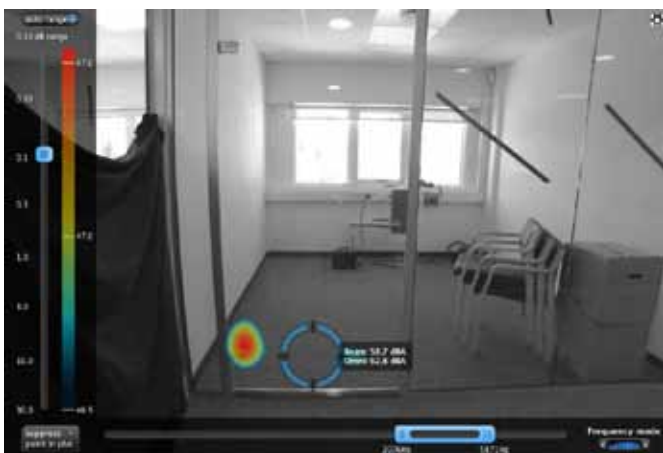
In addition to the main weaknesses being the door hinge and the seal between the door and the floor, also the top right corner of the door wasn't closed tightly enough, so that noise leaked through here as well. This weakness could be clearly heard with the virtual microphone. Since it was weaker than the two main sources, it was better visualised in the image by using the acoustic eraser to try to remove the main sources from the visualisation as seen in the images below.

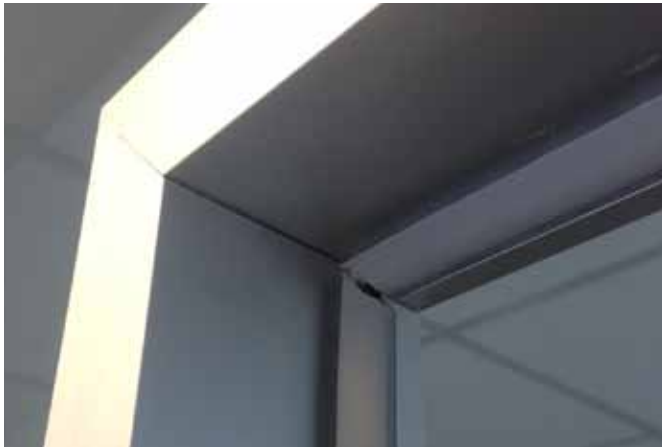
By closer inspection one could see how the rubber strip around the door edge wasn't completely sealed shut in this position as seen from the image below.

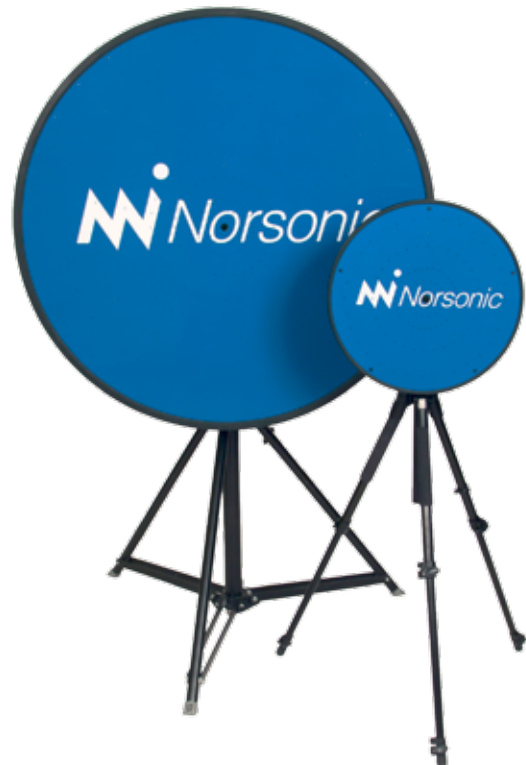
The digital microphone elements are protected behind a disc-shaped carbon fibre enclosure, and a dust and water repellent mesh is protecting the microphones from dust and moisture. The robust and sturdy construction also ensures that all microphones are kept in the correct position – important for field applications. The small distance between the microphones in the inner circle is important for low spatial aliasing at higher frequencies. The large number of microphones also contributes to the wide measurement range and the low self-noise. The signal in the selected direction is based on the weighted average of all microphones and is therefore far below the self-noise from a single microphone.
