# Nor848A Acoustic camera

## Filming Low-Frequency Structure Born Noise With Acoustic Camera

### Measurements in apartment building Oslo, Norway, September 2015

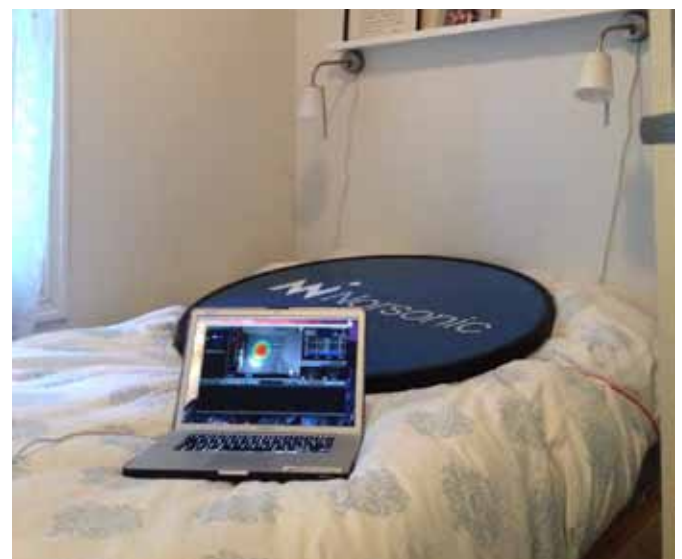
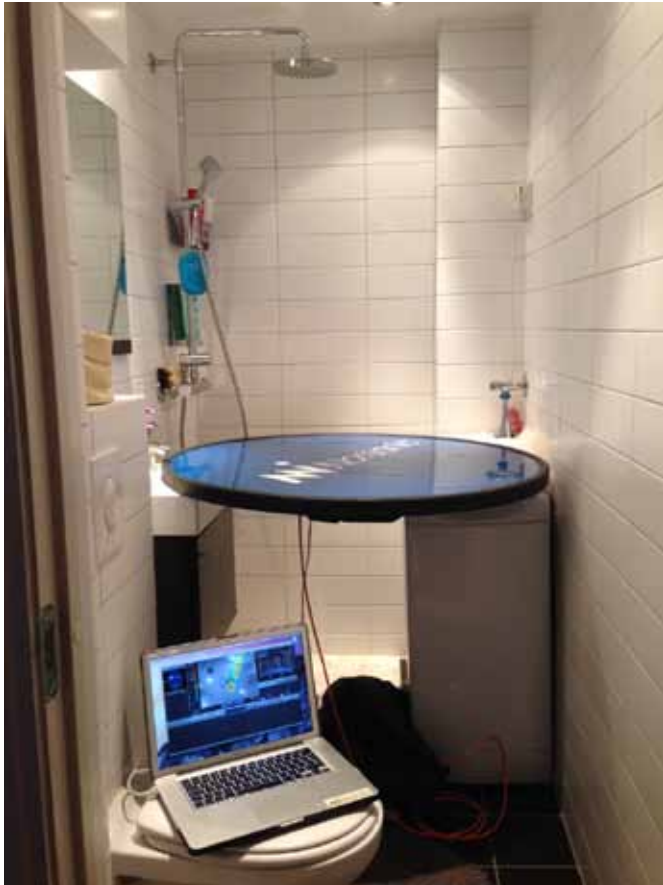
larger in size will have better resolution for all frequencies, and will also be able to go lower in frequency content. Even though the Nor848A-10 has a diameter of 1.0 meter, it weighs in at only 11 kg with tripod mounting brackets, and could easily be mounted on a tripod for inspection of the air fan in the attic, or laid down on the floor, or a bed or similar for inspection of the roof in the bedroom and bathroom of the apartment.

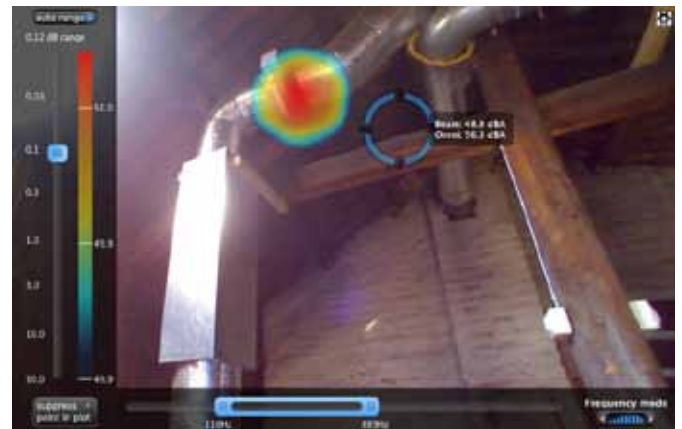
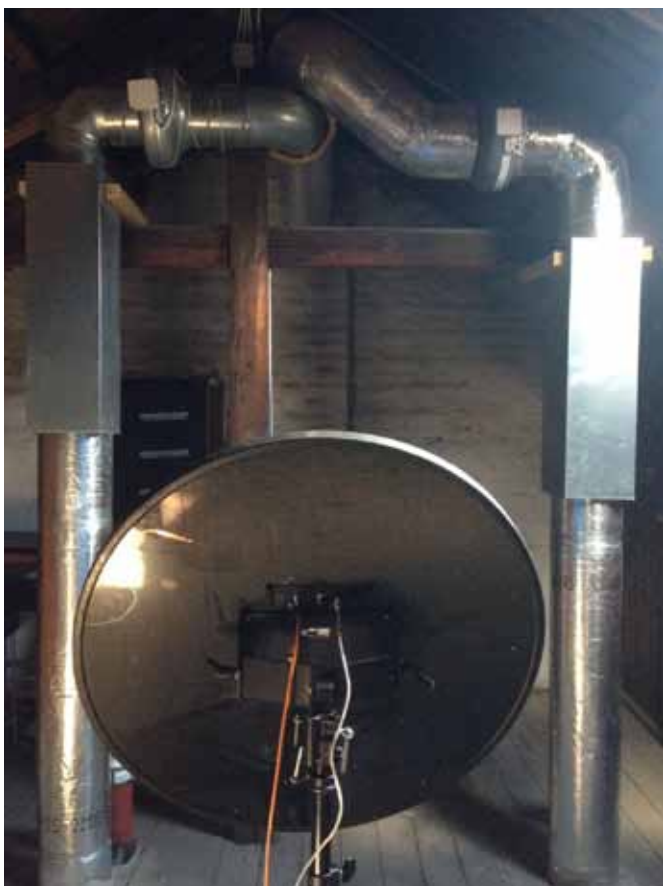
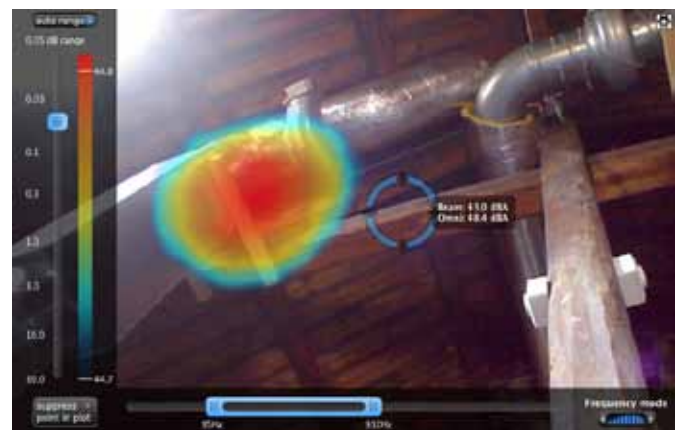
Looking at the recordings from the attic, it was clear that the intake fan was the main culprit having a dominating fundamental frequency at 200 Hz. Also several harmonics of the fundamental frequency could be seen in the frequency spectrum. Since the distance between the attic and the measurement apartment was several floors, and

the sound pressure level of the fan noise in the attic was around 40-50 dB, it would have been impossible for the noise in the apartment to be anything other than structure born noise. By inspecting the pipes it was seen that they were cemented in place to the building structure itself without any form of vibration damping measures in place.
